## Case Study – Borehole Cross-Connection

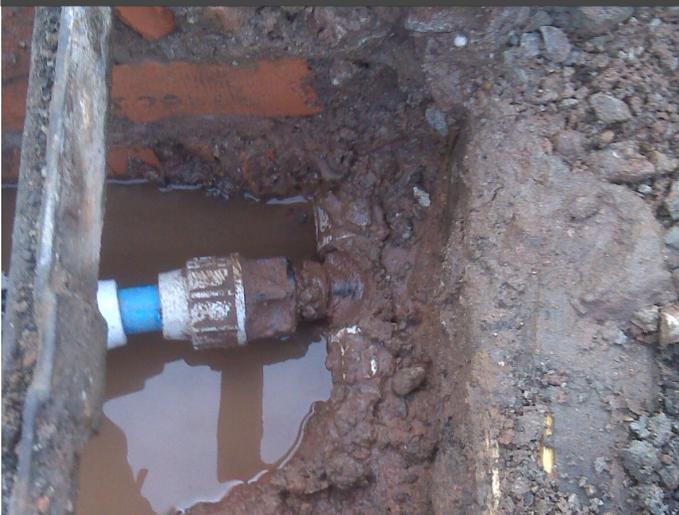
The Water Regulations Technicians soon identified the cause of the problem. It turned out to be a direct cross-connection between the new borehole and the incoming drinking water mains.

Before – borehole cross-connected to the drinking water supply

This was immediately disconnected and as a precautionary measure 17 local properties were issued with 'Do Not Drink' notices, until the water company had completed its investigations and were sure the water supply was safe to drink.

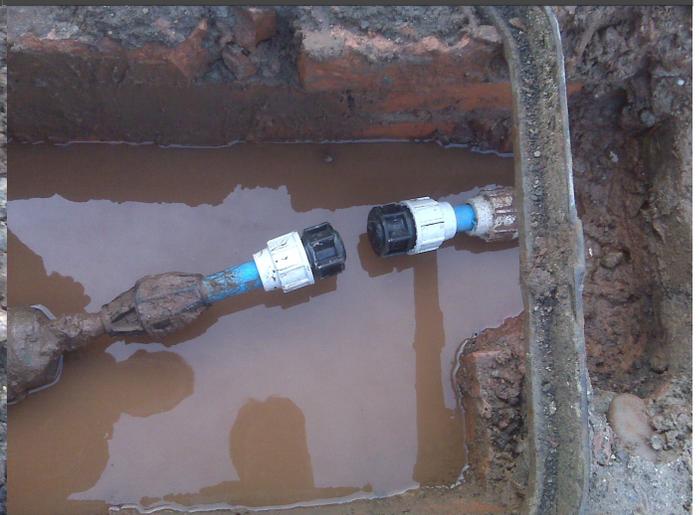
After – temporary disconnection of pipework
