Farm borehole cross connection discovered following customer complaints.

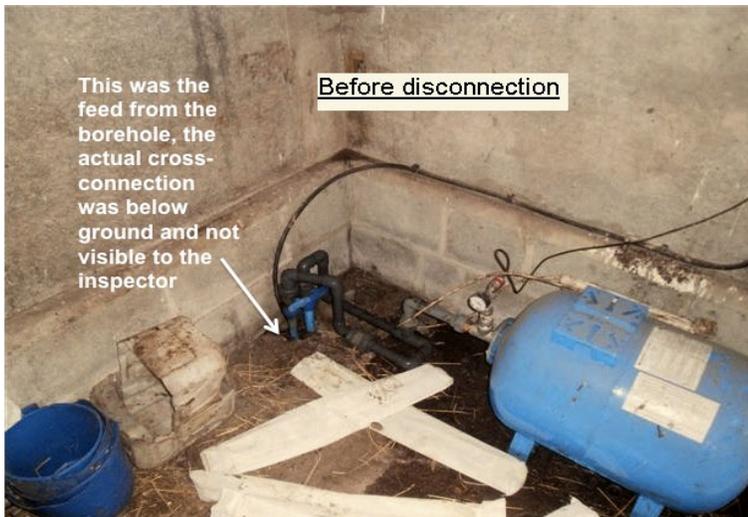
At one of these properties the inspectors identified a private borehole distribution system with a direct cross connection to mains water supplying the farm. This had been installed by a private borehole company without any

backflow protection. In fact the only means of separation was a gate valve which had been left partially open.

The Water Regulations Inspectors attending made the farmer disconnect the cross connection immediately, thus removing any risk or reoccurrence of contamination. The owner was subsequently prosecuted for the offence of installing a fitting without adequate backflow prevention [Schedule 2 paragraph 15 (1)] fined £400 and costs of £5000 awarded.

At the premises where the cross connection had been discovered the customer was given specific advice, again both verbal and in writing on how to reconnect their mains back up supply in a way which complied with the Water Supply (Water Fittings) Regulations. To further assist the customer and ensure that there was no further misunderstanding or problems a Regulations Inspector made several return visits to the property.
